Manhole Inspection Summary

Manhole # S45C__049MH

Insp Date: **7/31/08 11:18 AM**

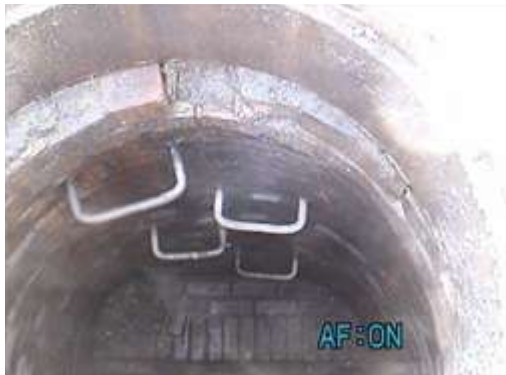
Defect 2

Condition: ☐ Sound ☐ Cracked ☐ Root Intrusion ☒ **Loose Brick** ☐ Deteriorated

Infiltration: ☐ None ☐ Joint ☐ Cracks ☒ **Mortar** ☐ Roots ☐ Wall

Loose Brick

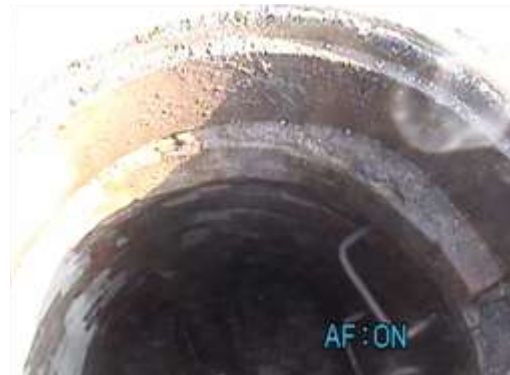
Defect 1

☒ **Leaks**

Frame Leaks

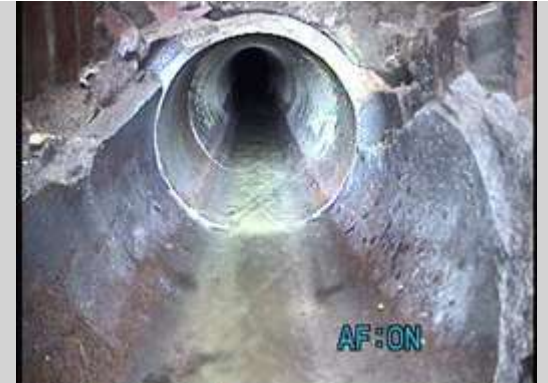
12 O'Clock Outflow

8 in. Circular Gravity Sewer
Pipe Out @ 12 O'Clock

Pipe Height: **8.4** (in.) Rod and Bar (Angled)
Pipe Material: **Clay** ☐ Pipe Lined
Invert Depth: **8.60** (ft.) Flow Characteristics: **Fast**
Deposits: ☒ None ☐ Mud ☐ Sludge ☐ Debris ☐ Grease
Silt Depth: (in.) Deposits Extent:
Infiltration: **None** Pipe Seal Cond: **Sound**

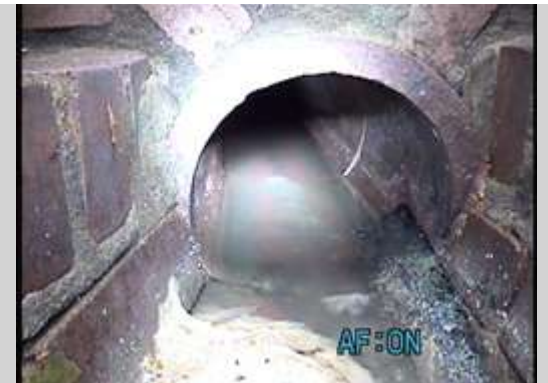
3 O'Clock Inflow

8 in. Circular Gravity Sewer
Pipe In @ 3 O'Clock

Pipe Height: **8.4** (in.) Rod and Bar (Angled)
Pipe Material: **Clay** ☐ Pipe Lined
Invert Depth: **8.50** (ft.) Flow Characteristics: **Fast**
Deposits: ☒ None ☐ Mud ☐ Sludge ☐ Debris ☐ Grease
Silt Depth: (in.) Deposits Extent:
Infiltration: **None** Pipe Seal Cond: **Sound**

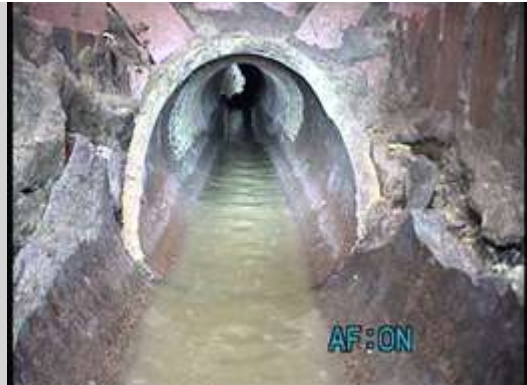
6 O'Clock Inflow

Pipe Height: **8.4** (in.) Rod and Bar (Angled)

Infiltration: **None** Pipe Seal Cond: **Sound**
